**Flood Control Project Maintenance  
Levee Inspections**

**2018 Channel Summary Report**

**Madera County FCWCA**

**Ash Slough**

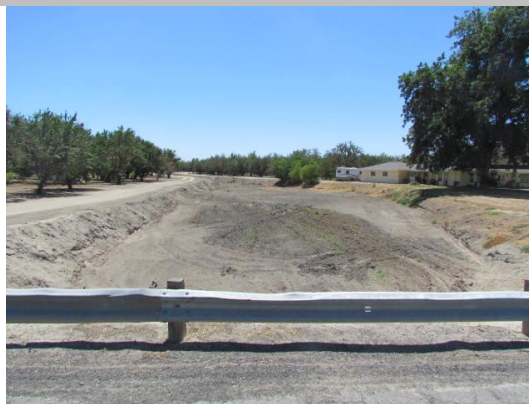
Photo 2 of 2 : CH\_2018\_NA0011\_40\_36\_20180601\_00055.jpg

Inspector Comments: Minimal vegetation is present that does not impede flow in the channel.

Looking west (downstream) at channel from Avenue 25 & Washington Road. (2015)

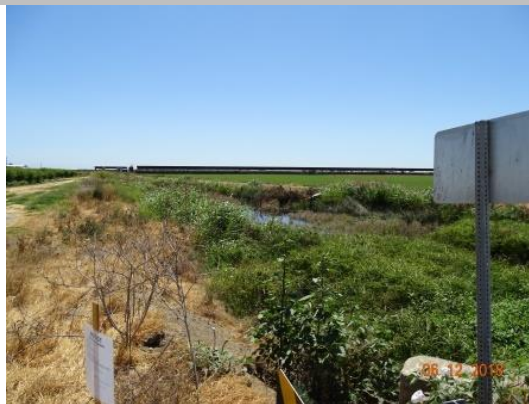
Photo 1 of 2 : CH\_2018\_NA0011\_40\_45\_20180614\_00100.jpg

Inspector Comments: Vegetation and log is present that could impede flow.

Looking upstream at the channel from Shultz Rd. (2018)

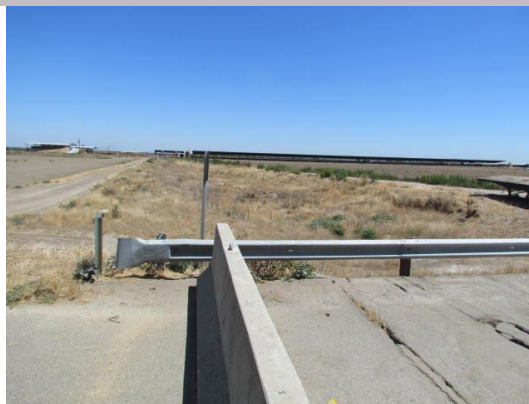
Photo 2 of 2 : CH\_2018\_NA0011\_40\_45\_20180601\_00067.jpg

Inspector Comments: Vegetation and log is present that could impede flow.

Looking east (upstream) at channel from Shultz Road. (2015)

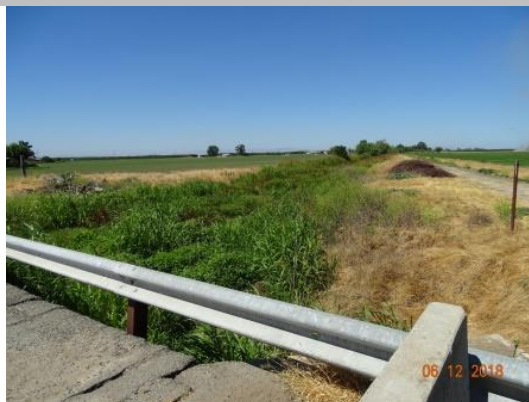
Photo 1 of 2 : CH\_2018\_NA0011\_40\_48\_20180614\_00101.jpg

Inspector Comments: Vegetation is present that could impede flow.

Looking downstream at the channel from Schultz Rd. (2018)

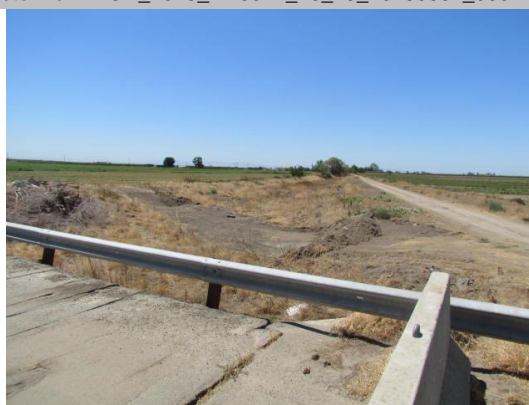
Looking west (downstream) at channel from Shultz Rd. (2015)

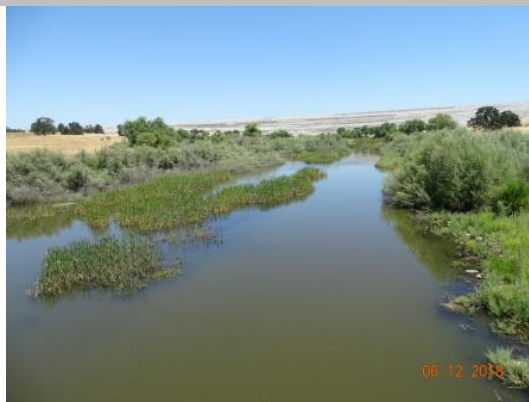
Photo 1 of 2 : CH\_2018\_NA0011\_41\_1\_20180614\_00038.jpg

Inspector Comments: There are grasses in the channel but flow is not impeded.

Fresno River looking upstream towards Hidden Dam. (2018)

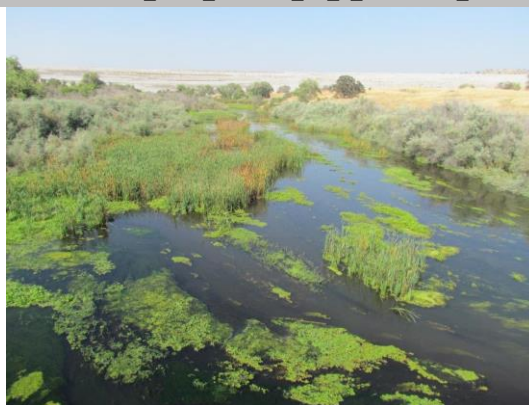
Photo 2 of 2 : CH\_2018\_NA0011\_41\_1\_20180601\_00002.jpg

Fresno River looking upstream from Daulton Drive bridge crossing. (2016)

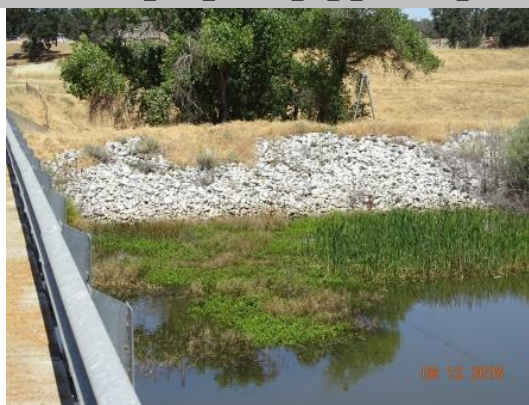
Photo 1 of 2 : CH\_2018\_NA0011\_41\_4\_20180614\_00039.jpg

Rating **	A	Issue No.	4	GPS Lat/Long
Issue Type +	Ma	Location *		37.103916 °
Category	Rivers, Channels & Designated Flood			-119.888060 °
Item	Revetments			
DWR ID	DWR_NA0011_41_c_2016_4			
Action/Comments				
Inspector Comments: Existing riprap protection is properly maintained.

View of upstream right bank revetment. (2018)

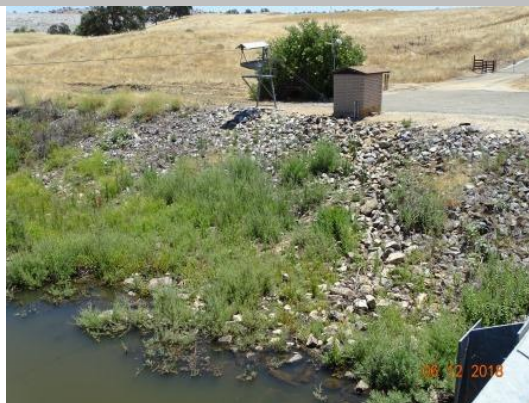
Photo 2 of 2 : CH\_2018\_NA0011\_41\_4\_20180614\_00040.jpg

View of upstream left bank revetment. (2018)

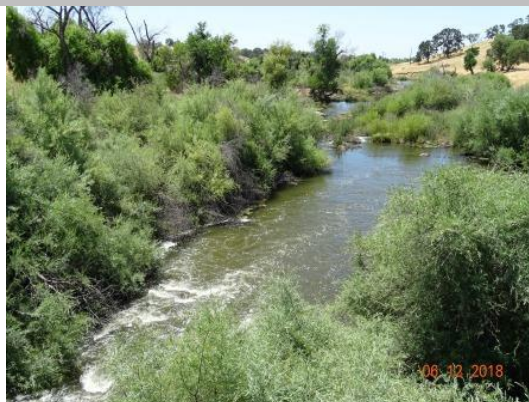
Photo 1 of 2 : CH\_2018\_NA0011\_41\_6\_20180614\_00041.jpg

Looking downstream at the channel from Rd 603. (2018)

Inspector Comments: The vegetation on the downstream of bridge crossing should be maintained.

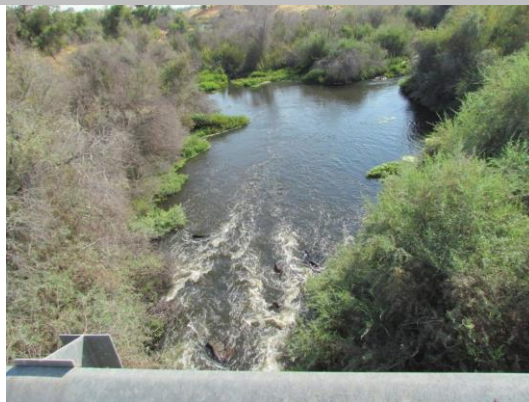
Photo 2 of 2 : CH\_2018\_NA0011\_41\_6\_20180601\_00007.jpg

Fresno River downstream from the Daulton Drive crossing.

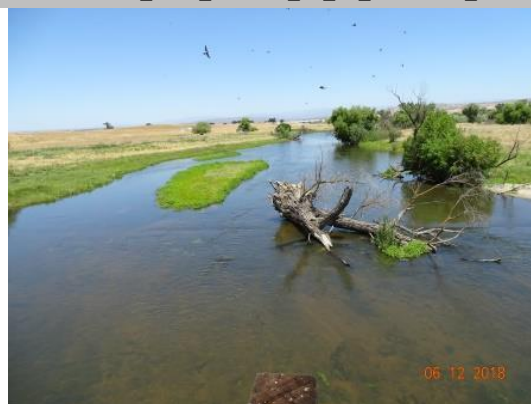
Photo 1 of 2 : CH\_2018\_NA0011\_41\_11\_20180614\_00042.jpg

Inspector Comments: Minimal, scattered obstructions and vegetation. A downed tree is in the channel but the flow is not impeded.

Looking upstream at the channel from Timber Bridge crossing. (2018)

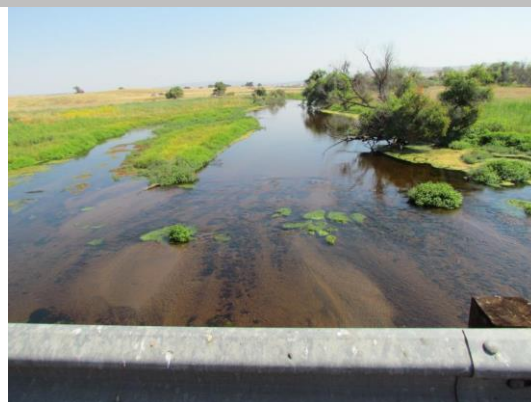
Photo 2 of 2 : CH\_2018\_NA0011\_41\_11\_20180601\_00009.jpg

Fresno River looking upstream from the timber bridge crossing.(2016)

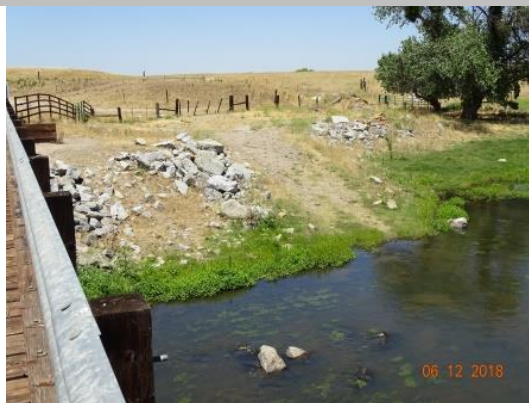
Photo 1 of 1 : CH\_2018\_NA0011\_41\_14\_20180614\_00043.jpg

Rating **	A	Issue No.	14	GPS Lat/Long
Issue Type +	Ma	Location *		37.070059 °
Category	Rivers, Channels & Designated Flood			-119.910233 °
Item	Revetments			
DWR ID	DWR_NA0011_41_c_2016_14			
Action/Comments				
Inspector Comments: Right bank revetment has gaps but no scouring activity or bank undercutting.

View of upstream right bank rip-rap. (2018)

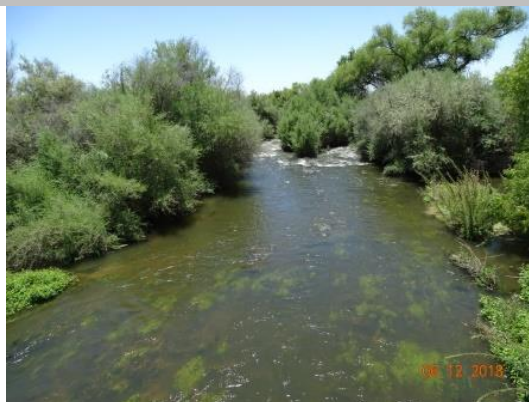
Photo 1 of 2 : CH\_2018\_NA0011\_41\_16\_20180614\_00044.jpg

Check Point / View				
Timber Bridge at Madera Canal / Down				
Rating **	M	Issue No.	16	GPS Lat/Long
Issue Type +	Ma	Location *		37.070059°
Category	Rivers, Channels & Designated Flood			-119.910233°
Item	Vegetation & Obstructions			
DWR ID	DWR_NA0011_41_c_2016_16			
Action/Comments				
Inspector Comments: Vegetation present in channel that could impact flow.

Looking downstream at the channel from Timber Bridge crossing. (2018)

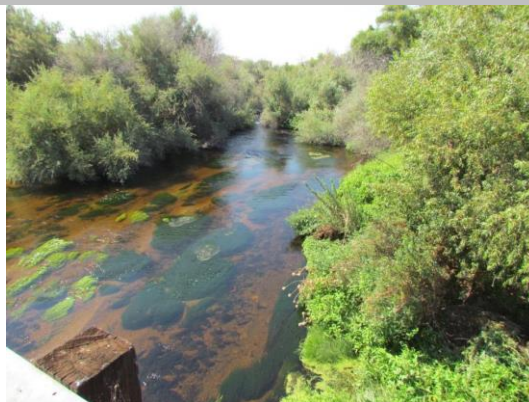
Photo 2 of 2 : CH\_2018\_NA0011\_41\_16\_20180601\_00011.jpg

Fresno River downstream from the timber bridge crossing.(2016)

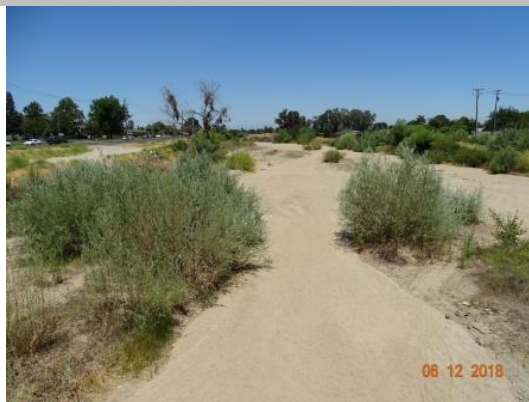
Photo 1 of 2 : CH\_2018\_NA0011\_41\_21\_20180614\_00045.jpg

Inspector Comments: Minimal vegetation in channel that would not impede the flow.

Looking upstream at the channel from Cleveland Ave. (2018)

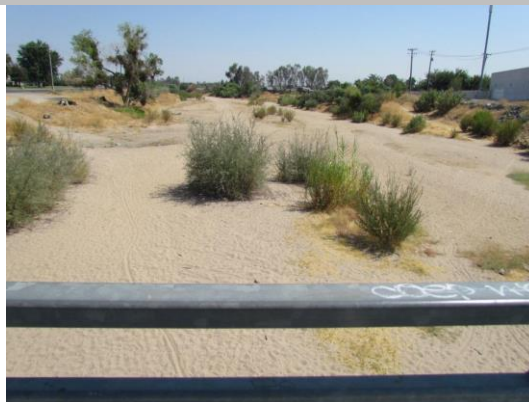
Photo 2 of 2 : CH\_2018\_NA0011\_41\_21\_20180601\_00013.jpg

Fresno River looking upstream from Cleveland Avenue crossing.(2016)

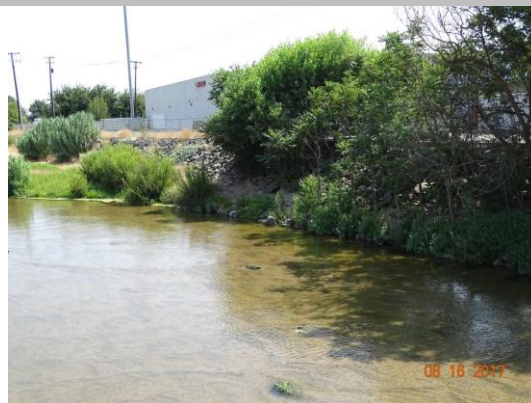
Photo 1 of 2 : CH\_2018\_NA0011\_41\_24\_20180601\_00014.jpg

Rating **	M	Issue No.	24	GPS Lat/Long
Issue Type +	Ma	Location *		36.974268 °
Category	Rivers, Channels & Designated Flood			-120.043922 °
Item	Revetments			
DWR ID	DWR_NA0011_41_c_2016_24			
Action/Comments				
Inspector Comments: Revetment requires removal of vegetation..

Looking northeast (upstream) at revetment on left bank of the channel.

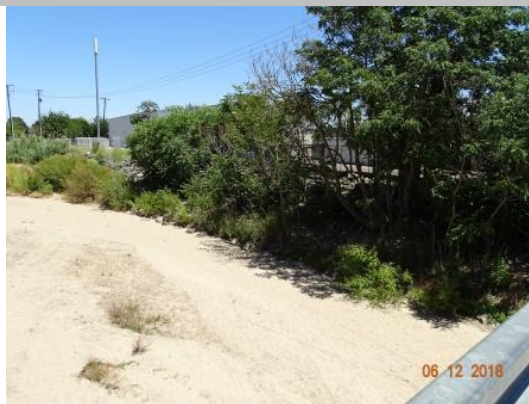
Photo 2 of 2 : CH\_2018\_NA0011\_41\_24\_20180614\_00046.jpg

Rating **	M	Issue No.	24 (cont)	GPS Lat/Long
Issue Type +	Ma	Location *		36.974268 °
Category	Rivers, Channels & Designated Flood			-120.043922 °
Item	Revetments			
DWR ID	DWR_NA0011_41_c_2016_24			
Action/Comments				
Inspector Comments: Revetment requires removal of vegetation..

View of revetment on upstream left bank. (2018)

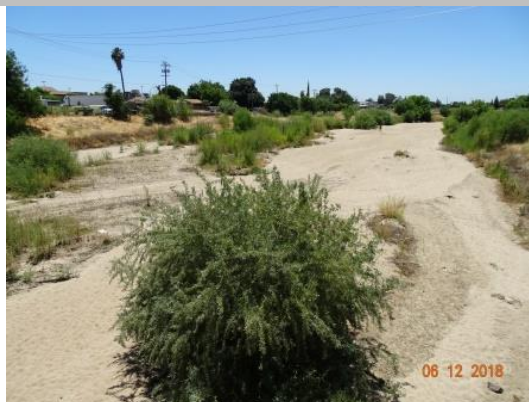
Photo 1 of 2 : CH\_2018\_NA0011\_41\_26\_20180614\_00047.jpg

Rating **	A	Issue No.	26	GPS Lat/Long
Issue Type +	Ma	Location *		36.974268 °
Category	Rivers, Channels & Designated Flood			-120.043922 °
Item	Vegetation & Obstructions			
DWR ID	DWR_NA0011_41_c_2016_26			
Action/Comments				
Inspector Comments: Minimal vegetation in the channel that is not impeding flow.

Looking downstream at the channel from Cleveland Ave. (2018)

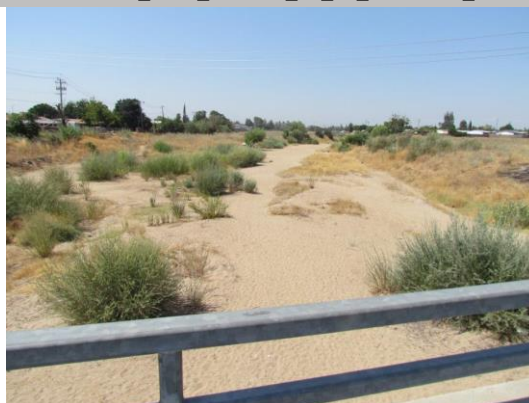
Photo 2 of 2 : CH\_2018\_NA0011\_41\_26\_20180601\_00016.jpg

Fresno River looking downstream from Cleveland Avenue.(2016)

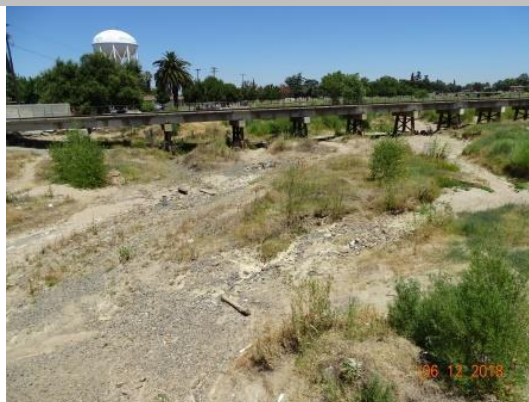
Photo 1 of 2 : CH\_2018\_NA0011\_41\_31\_20180614\_00048.jpg

Rating **	A	Issue No.	31	GPS Lat/Long
Issue Type +	Ma	Location *		36.968885 °
Category	Rivers, Channels & Designated Flood			-120.068191 °
Item	Vegetation & Obstructions			
DWR ID	DWR_NA0011_41_c_2016_31			
Action/Comments				
Inspector Comments: Vegetation and minor debris in the channel that does not appear to impede flow.

Looking upstream at the channel from Gateway Dr. (2018)

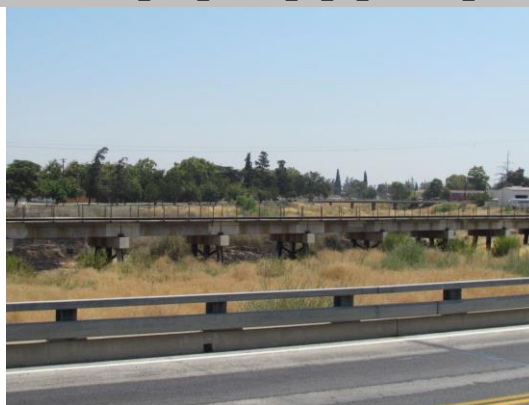
Photo 2 of 2 : CH\_2018\_NA0011\_41\_31\_20180601\_00018.jpg

Fresno River from Gateway crossing looking upstream of the channel.(2016)

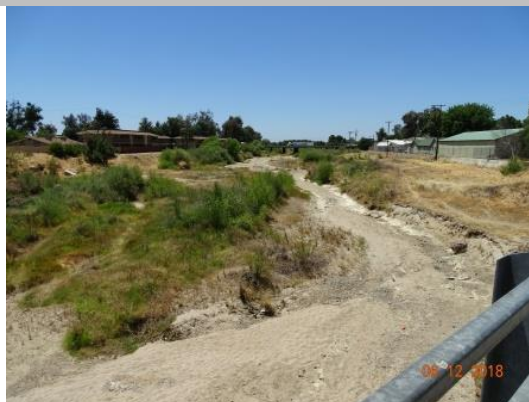
Photo 1 of 2 : CH\_2018\_NA0011\_41\_36\_20180614\_00049.jpg

Rating **	A	Issue No.	36	GPS Lat/Long
Issue Type +	Ma	Location *		36.968885 °
Category	Rivers, Channels & Designated Flood			-120.068191 °
Item	Vegetation & Obstructions			
DWR ID	DWR_NA0011_41_c_2016_36			
Action/Comments				
Inspector Comments: Minimal, scattered obstructions or vegetation. The flow is not impeded.

Looking downstream at the channel from Gateway Dr. (2018)

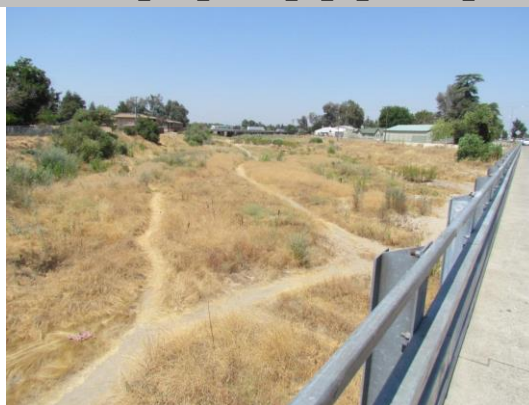
Photo 2 of 2 : CH\_2018\_NA0011\_41\_36\_20180601\_00020.jpg

Fresno River from Gateway Bridge crossing looking downstream.(2016)

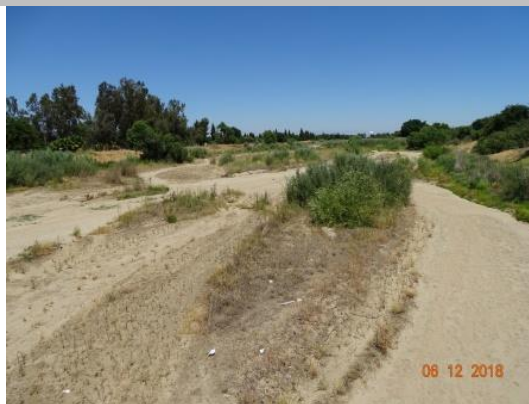
Photo 1 of 2 : CH\_2018\_NA0011\_41\_41\_20180614\_00050.jpg

Rating **	A	Issue No.	41	GPS Lat/Long
Issue Type +	Ma	Location *		36.967942 °
Category	Rivers, Channels & Designated Flood			-120.092149 °
Item	Vegetation & Obstructions			
DWR ID	DWR_NA0011_41_c_2016_41			
Action/Comments				
Inspector Comments: Some vegetation but flow is not impeded.

Looking upstream at the channel from Granada Ave. (2018)

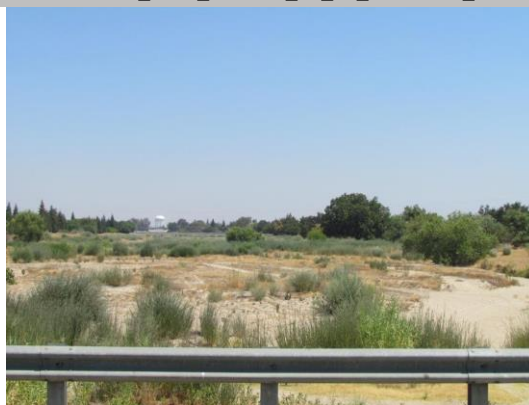
Photo 2 of 2 : CH\_2018\_NA0011\_41\_41\_20180601\_00022.jpg

Fresno River from Granada Avenue crossing looking upstream.(2016)

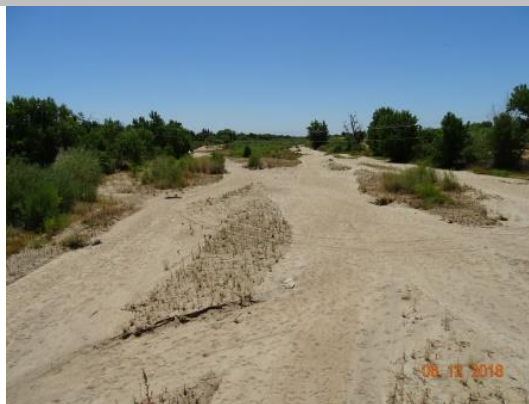
Photo 1 of 2 : CH\_2018\_NA0011\_41\_46\_20180614\_00051.jpg

Rating **	A	Issue No.	46	GPS Lat/Long
Issue Type +	Ma	Location *		36.967942 °
Category	Rivers, Channels & Designated Flood			-120.092149 °
Item	Vegetation & Obstructions			
DWR ID	DWR_NA0011_41_c_2016_46			
Action/Comments				
Inspector Comments: Some vegetation but flow is not impeded.

Looking downstream at channel from Granada Ave. (2018)

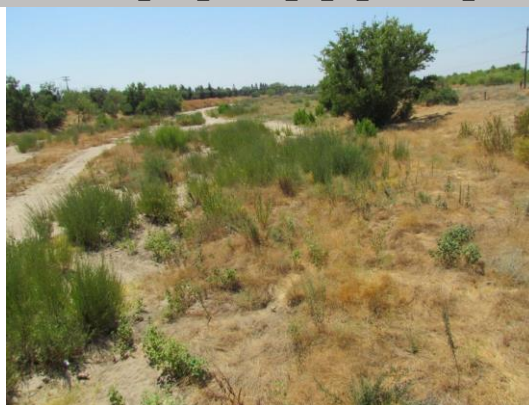
Photo 2 of 2 : CH\_2018\_NA0011\_41\_46\_20180601\_00024.jpg

Fresno River downstream from Granada Avenue crossing.(2016)

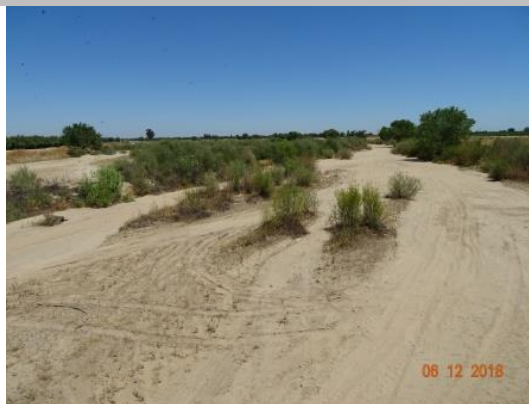
Photo 1 of 2 : CH\_2018\_NA0011\_41\_81\_20180614\_00052.jpg

Rating **	A	Issue No.	81	GPS Lat/Long
Issue Type +	Ma	Location *		36.967550 °
Category	Rivers, Channels & Designated Flood			-120.128450 °
Item	Vegetation & Obstructions			
DWR ID	DWR_NA0011_41_c_2017_81			
Action/Comments				
Inspector Comments: Some vegetation but flow is not impeded.

Looking upstream at the channel from Rd 23. (2018)

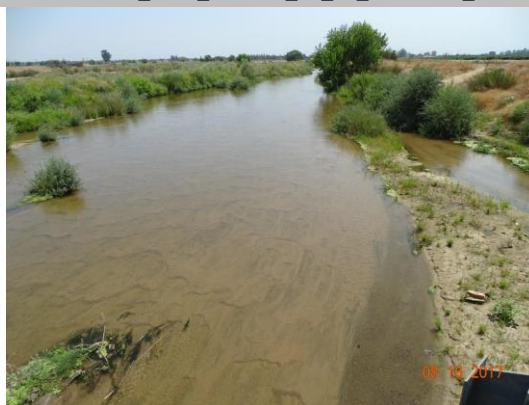
Photo 2 of 2 : CH\_2018\_NA0011\_41\_81\_20180601\_00037.jpg

Looking east (upstream) at the channel from Rd 23.

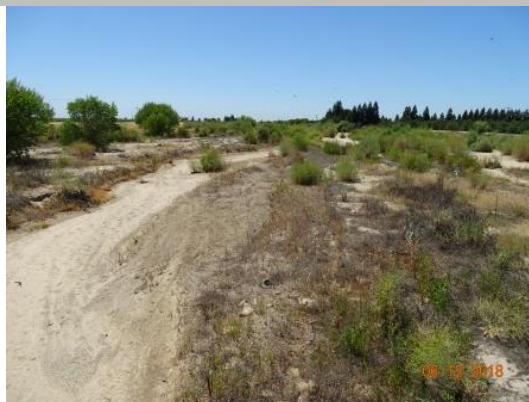
Photo 1 of 2 : CH\_2018\_NA0011\_41\_56\_20180614\_00053.jpg

Rating **	A	Issue No.	56	GPS Lat/Long
Issue Type +	Ma	Location *		36.967550 °
Category	Rivers, Channels & Designated Flood			-120.128450 °
Item	Vegetation & Obstructions			
DWR ID	DWR_NA0011_41_c_2016_56			
Action/Comments				
Inspector Comments: Some vegetation in the channel but the flow is not impeded.

Looking downstream at the channel from Rd 23. (2018)

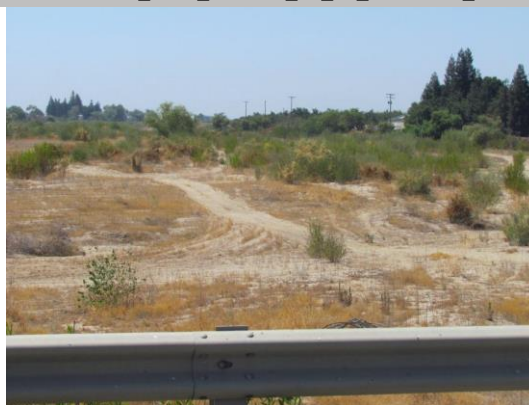
Photo 2 of 2 : CH\_2018\_NA0011\_41\_56\_20180601\_00026.jpg

Fresno River looking downstream from Road 23.(2016)

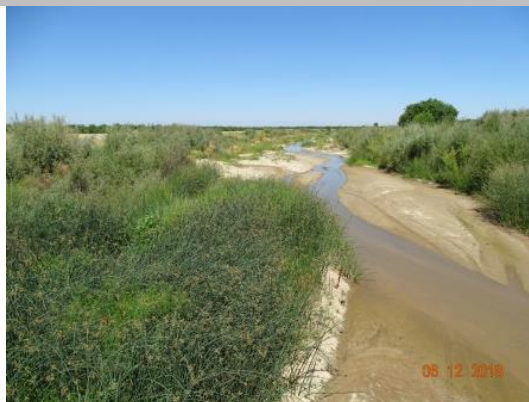
Photo 1 of 2 : CH\_2018\_NA0011\_41\_61\_20180614\_00054.jpg

Inspector Comments: Some vegetation but the flow is not impeded.

Looking upstream at channel from Rd 20. (2018)

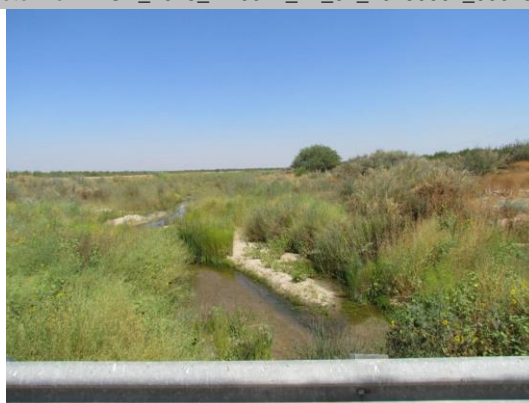
Photo 2 of 2 : CH\_2018\_NA0011\_41\_61\_20180601\_00028.jpg

Fresno River looking upstream from Road 20 bridge crossing.(2016)

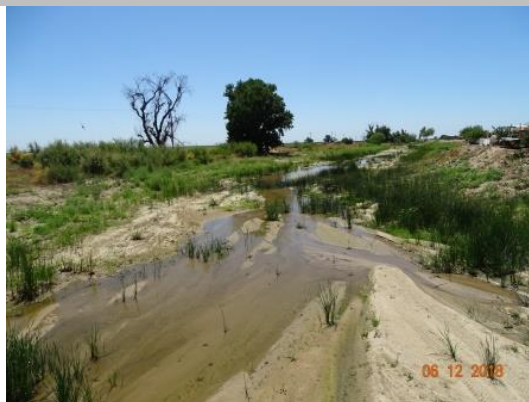
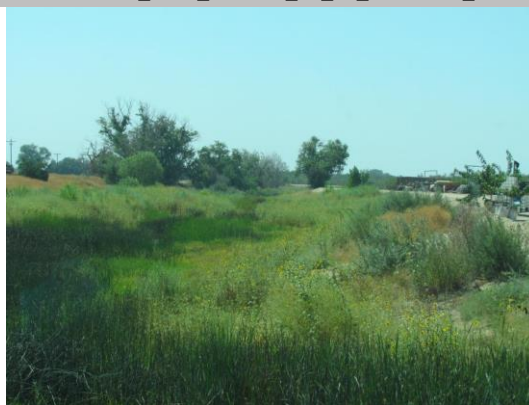
Photo 1 of 2 : CH\_2018\_NA0011\_41\_66\_20180614\_00055.jpg

Rating **	A	Issue No.	66	GPS Lat/Long
Issue Type +	Ma	Location *		36.982340 °
Category	Rivers, Channels & Designated Flood			-120.184160 °
Item	Vegetation & Obstructions			
DWR ID	DWR_NA0011_41_c_2016_66			
Action/Comments				
Inspector Comments: Some vegetation in the channel but the flow is not impeded.

Looking downstream at the channel from Rd 20. (2018)

Fresno River looking downstream from Road 20.(2016)

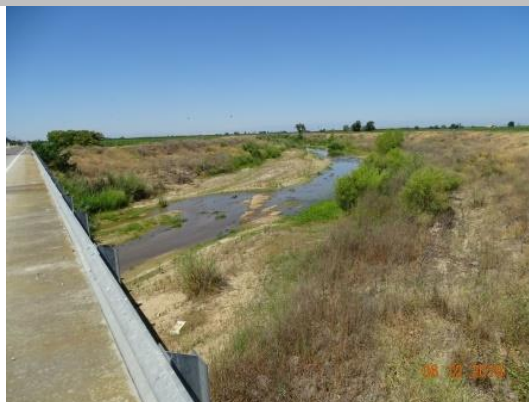
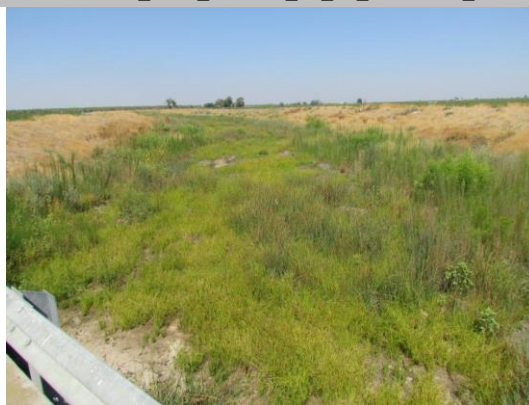
Photo 1 of 2 : CH\_2018\_NA0011\_41\_71\_20180614\_00056.jpg

Rating **	A	Issue No.	71	GPS Lat/Long
Issue Type +	Ma	Location *		36.975610 °
Category	Rivers, Channels & Designated Flood			-120.202318 °
Item	Vegetation & Obstructions			
DWR ID	DWR_NA0011_41_c_2016_71			
Action/Comments				
Inspector Comments: Minimal vegetation present that will not impede flow.

Looking upstream at the channel from Rd 19 D/S limit. (2018)

Fresno River looking upstream from Rd. 19, D/S Limits of the River Channel.(2016)

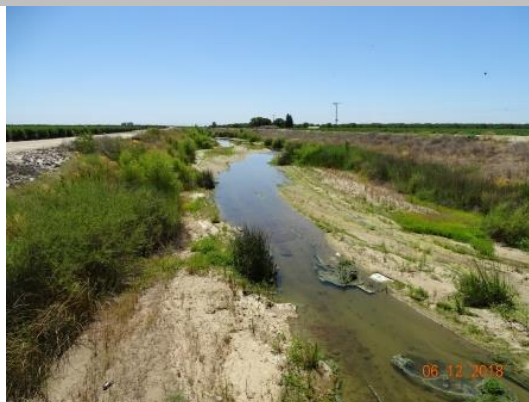
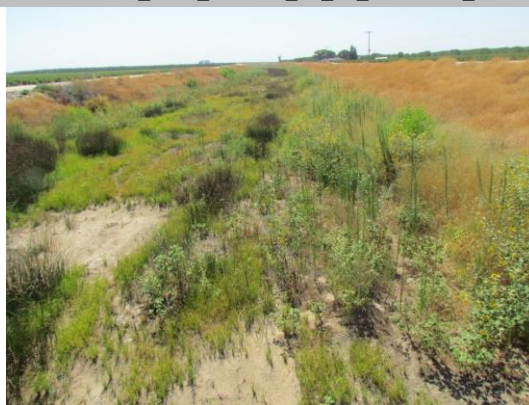
Photo 1 of 2 : CH\_2018\_NA0011\_41\_76\_20180614\_00057.jpg

Rating **	A	Issue No.	76	GPS Lat/Long
Issue Type +	Ma	Location *		36.975610°
Category	Rivers, Channels & Designated Flood			-120.202318°
Item	Vegetation & Obstructions			
DWR ID	DWR_NA0011_41_c_2016_76			
Action/Comments				
Inspector Comments: Some vegetation but the flow is not impeded.

Looking downstream at the channel from Rd 19 D/S limit. (2018)

Fresno River looking downstream from Rd.19.(2016)

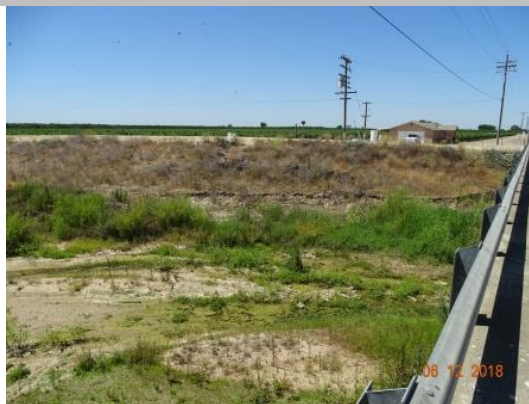
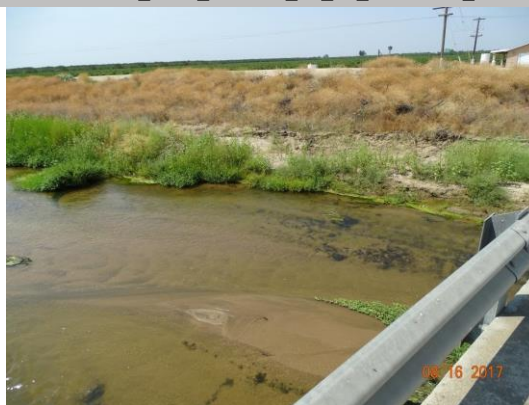
Photo 1 of 2 : CH\_2018\_NA0011\_41\_78\_20180614\_00058.jpg

Inspector Comments: Minor erosion identified on the right bank downstream. Erosion would not impact channel capacity.

View of erosion on downstream right bank. (2018)

Looking northwest (downstream) at right bank of channel from Rd 19 D/S Limit.

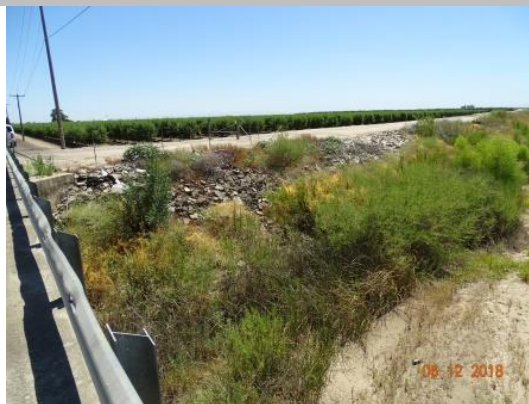
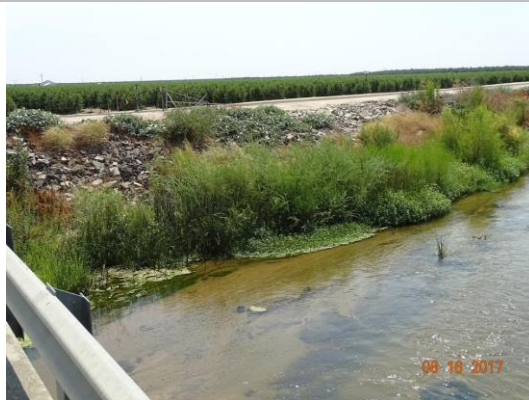
Photo 1 of 2 : CH\_2018\_NA0011\_41\_79\_20180614\_00059.jpg

Inspector Comments: Existing riprap on left bank is properly maintained.

Looking at revetment on downstream left bank. (2018)

Looking southwest (downstream) at the left bank of the channel from Rd 19 D/S limit.
